## RAIL CAR DOOR BEARING

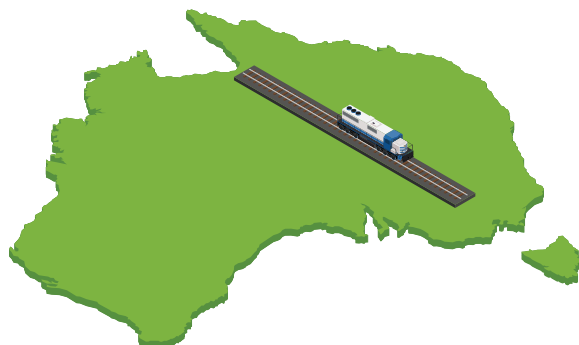
A major passenger rail operator in Australia was experiencing frequent premature failure of the door-opening mechanism.

Rail cars were taken out of service annually to make repairs at great expense.

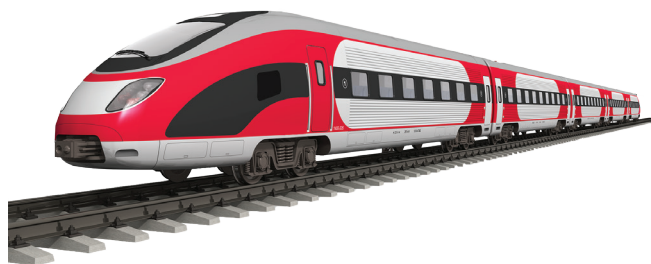
Koyo Engineers studied the issue and determined that the bearing shafts of the telescoping door mechanism were wearing due to insufficient strength which led to failure of the door mechanism. The bearing seals were also being displaced due to machine marks (grind lead) - this caused loss of lubrication.

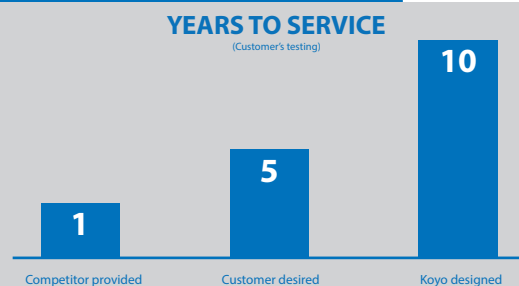
The customer put the new design on an accelerated test intended to simulate a 5-year pattern of use. Ultimately, the test was suspended at the equivalent of 10 years with no apparent damage or wear to the bearing or door mechanism.

With their expectations exceeded, the customer retrofitted their passenger rail cars with Koyo's solution.
